Building Inspection Report

14100 W. Cleveland Avenue, Phoenix, AZ 55555

03/18/2002

Report Number:

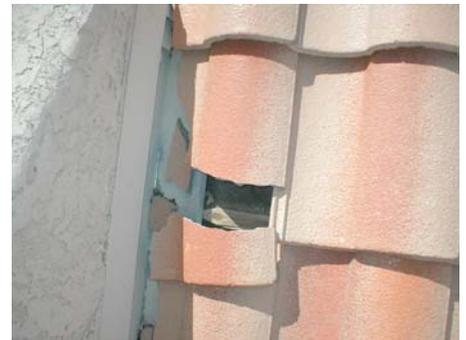
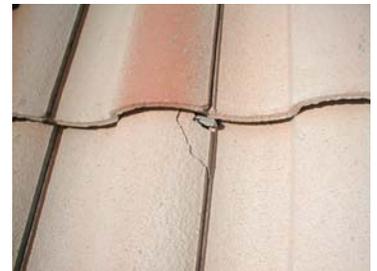
- **Major Concern, Repair:** Larger than normal crack or deterioration of tiles at the north slope were observed. This area should be repaired to prevent leaks or damage to roofing sub materials.
- **Major Concern, Repair:** Larger than normal crack or deterioration of tiles at the east slope were observed. This area should be repaired to prevent leaks or damage to roofing sub materials.

- **Monitor:** The roofing on the rear patio is in fair condition. We did not see evidence of active leaks nor need for immediate major repair.

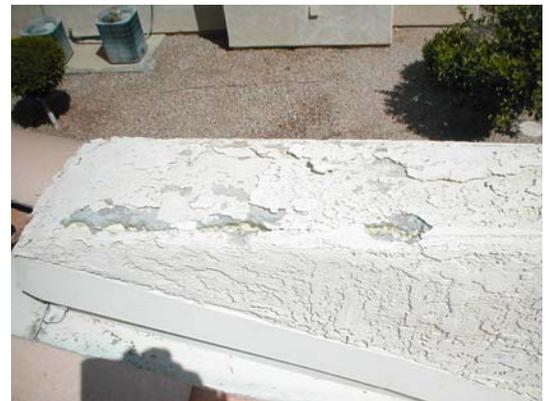
- **Monitor:** Common minor cracks were observed on the exterior walls of the house in various locations. This implies that structural movement has occurred. The location, size, shape of these cracks is common. The inspection did not find evidence of significant movement requiring immediate major repairs.
- **Repair:** Localized damage of the stucco exterior walls at the north and south side of the home above the patio should be repaired. There is extra risk of hidden damage in such areas.

- **Repair:** Tree branches in various locations should be trimmed away from the house to avoid damage to the building.
- **Repair:** Vines and shrubbery growing on or near the exterior walls in many locations should be kept trimmed away from siding, window trims, and the eaves to reduce risk of insect and water damage.

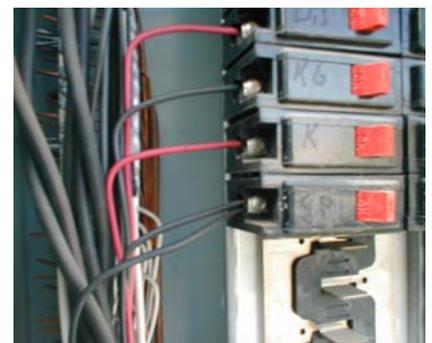
- **Repair:** Circuits within the main distribution panel that are doubled up (referred to as "double taps") should be separated. Each circuit should be served by a separate fuse or breaker.
- **Repair:** The door to the main panel does not close properly, this condition could leave the electrical panel exposed to the elements.

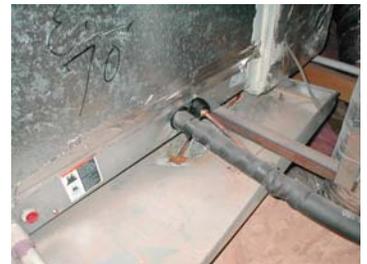
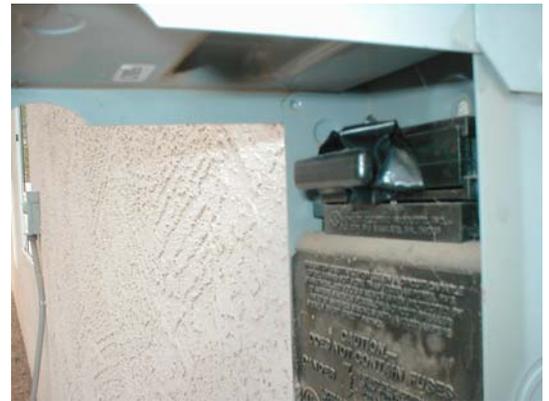
- **Improve:** The dirty air filter should be replaced.
- **Monitor:** The auxiliary drip pan under the indoor unit on the north side of the home has rust in the pan indicating prior leakage.
- **Major Concern, Repair:** The main disconnect to the west compressor unit has overheated.
- **Repair:** The main disconnect to the east compressor unit shows signs of handyman repairs. Electrical tape has been wrapped around the disconnect. This condition should be investigated to determine reason for the tape.

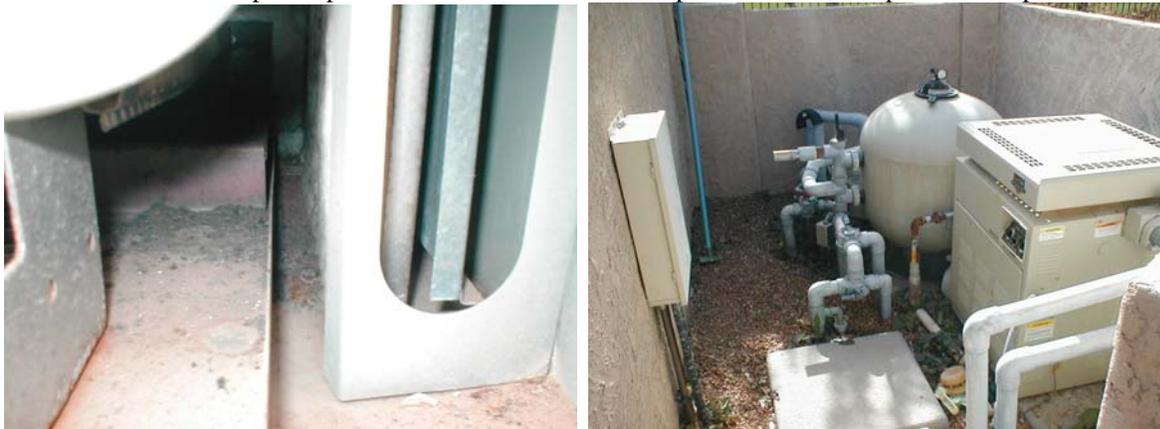
- **Monitor:** Rust was observed in the heating unit, it is recommended that the unit be serviced by a qualified contractor.

- **Safety Issue, Improve:** It is recommended that a second barrier fence be installed to further prevent access to the pool area by children. The installation of a barrier fence could greatly reduce the possibility of an accidental drowning.
